# An Unusual Case of Embolic Stroke:

## A Permanent Ventricular Pacemaker Lead Entirely Within the Arterial System Documented by Transthoracic and Transesophageal Echocardiography

*A pacemaker lead in the left ventricle is a rare complication of implantation. Recognition of this complication is important because thromboembolic events are associated. We report the first case, to our knowledge, of a patient who had a permanent pacemaker implanted via the left subclavian artery to the left ventricle, which is documented by electrocardiography, chest radiography, thoracic echocardiography, and transesophageal echocardiography. (ECHOCARDIOGRAPHY, Volume 16, May 1999)*

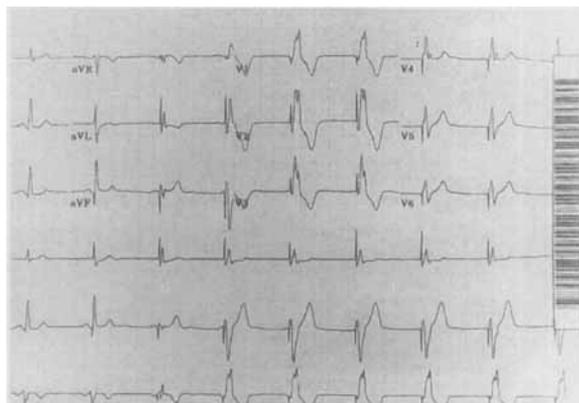
**Figure 1.** Twelve-lead electrocardiogram demonstrates the patient's own rhythm becoming a pacemaker rhythm with a right bundle-branch block morphology.

On presentation, the patient was taking 325 mg/day aspirin. A computed tomography scan of the brain was consistent with multiple scattered old embolic strokes. The admission electrocardiogram revealed a ventricular pacemaker rhythm with a right bundle-branch

block (RBBB) morphology (Fig. 1). Chest radiography (Fig. 2) revealed an abnormal course of the pacer wire. The patient was subsequently referred to our institution for further evaluation and treatment.

The diagnosis of a pacemaker tip within the LV may be suspected on the basis of a 12-lead electrocardiogram demonstrating an RBBB pattern while in the paced mode. However, an RBBB pattern may also occur with a lead positioned in the coronary sinus, penetration of the ventricular septum, perforation of the right ventricle, pacing of an enlarged right ventricular apex, and LV epicardial pacing.<sup>14</sup>

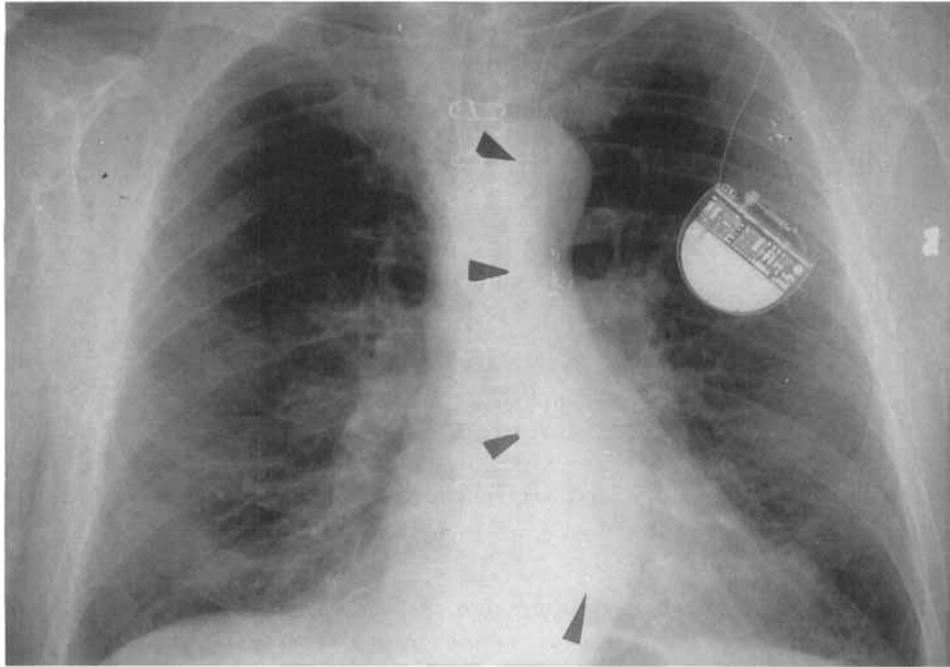
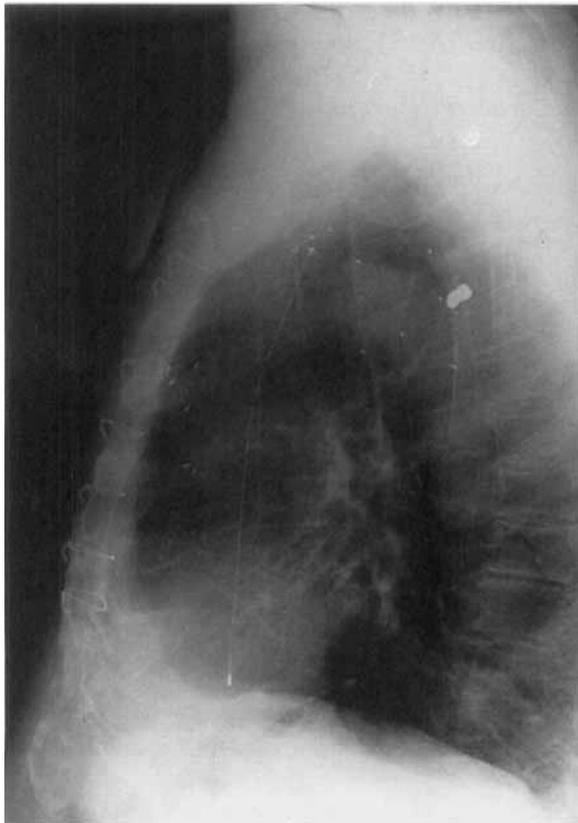
**Figure 2.** Posteroanterior and lateral chest radiographs. Posteroanterior view demonstrates the pacemaker lead remaining on the left side of the thoracic spine (arrows). Lateral view demonstrates the tip directed posteriorly.

Posteroanterior (PA) and lateral chest radiographs help localize the abnormal position of a pacemaker lead. A lead normally positioned in the right ventricular apex has a right lateral course through the right atrium on PA projection, with a slight bowing at the right ventric-

ular apex. The lateral projection normally reveals an anterior course of the lead to be adjacent to the sternum.<sup>3</sup>

This patient's PA projection chest radiograph revealed that the lead never crossed the midline, originating from the left subclavian artery. The lateral view documented a posteriorly directed tip within the cardiac shadow.

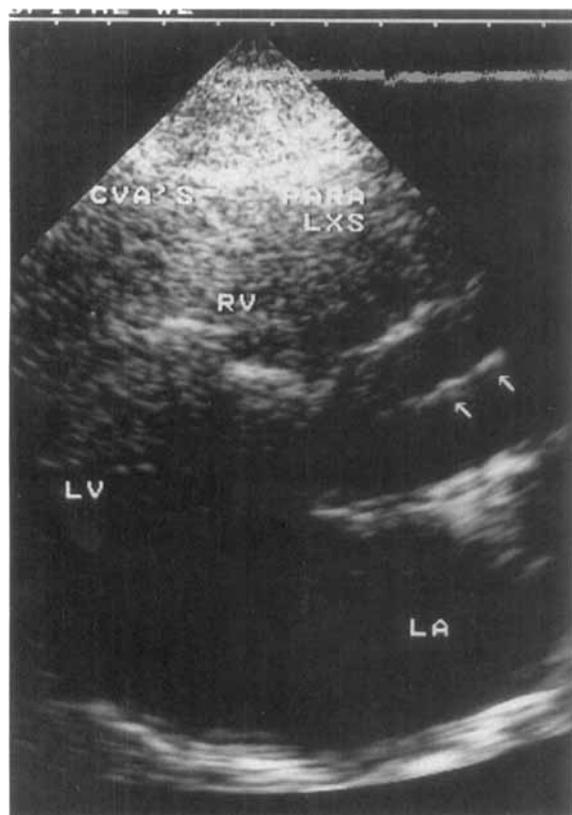
**Figure 3.** Parasternal long-axis transthoracic echocardiography demonstrates a bright linear structure (arrows) in the proximal ascending aorta. LA = left atrium; RV = right ventricle.

TTE revealed an abnormal bright linear structure consistent with a pacemaker lead crossing the aortic valve (Fig. 3). Suprasternal TTE imaging (Fig. 4) also revealed a bright linear structure entering the thoracic aorta from the left subclavian artery. The patient underwent a TEE examination. The pacemaker lead was noted to enter the thoracic aorta via the left subclavian artery (Fig. 5). A mass, suggestive of a laminated thrombus, was noted between the wall of the aorta and the pacemaker lead. The pacemaker lead was noted arching around the transverse aorta (Fig. 6). It then crossed the aortic valve (Fig. 7), across the left ventricular outflow tract (Fig. 8), and inserted into the wall of the LV, under the posterior mitral valve leaflet (Fig. 9), above the papillary muscle. Attached to a head of the papillary muscle was a 0.5-cm mobile mass, consistent with thrombus. The tip of the pacer wire did not have thrombus attached.

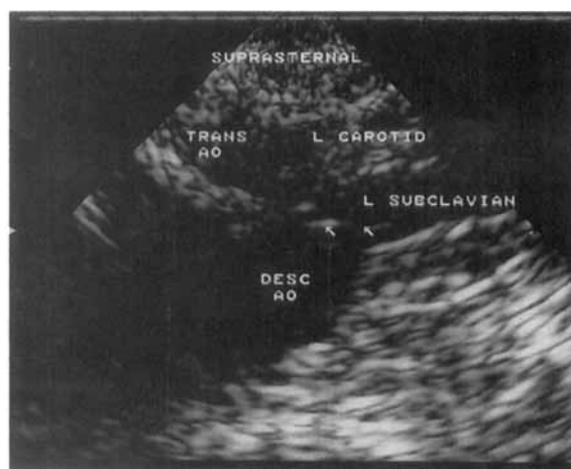
**Figure 4.** Suprasternal transthoracic echocardiography demonstrates a bright linear structure (arrows) entering the aorta (DESC AO) from the left subclavian artery (L Subclavian). L CAROTID = left carotid artery; TRANS AO = transverse aorta.

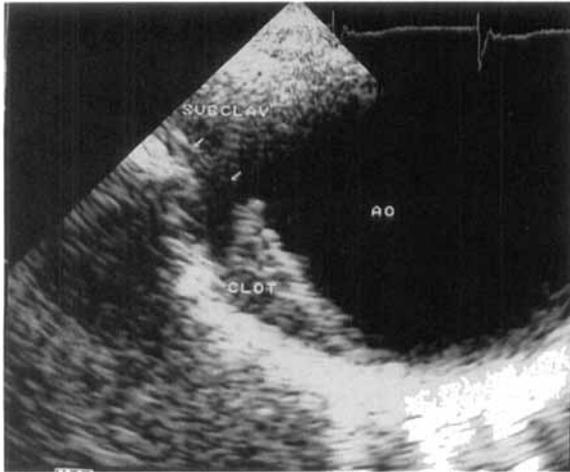
**Figure 5.** Transesophageal echocardiography in the upper esophagus with a 30° angle demonstrates pacemaker wire (arrows) entering the aorta (AO) from the left subclavian artery (SUBCLAV). Thrombus (CLOT) is noted between the wall of the aorta and the pacemaker wire.

The combined use of TTE and TEE fully documented the course of a chronically implanted pacemaker lead beginning from the left subclavian artery, entering the thoracic aorta, crossing the aortic valve, and going into the posterior wall of the LV. Importantly, thrombus was detected within the aorta and the LV cavity.

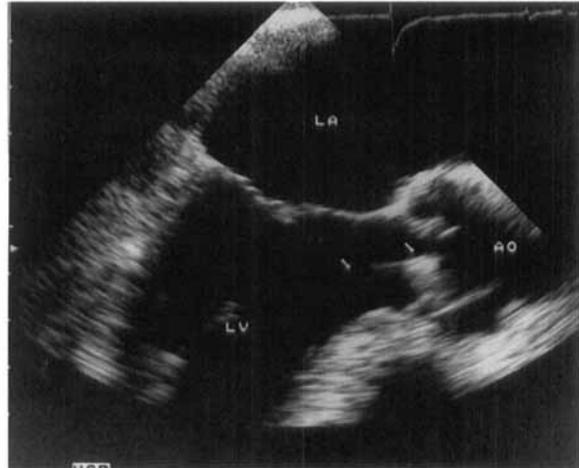
**Figure 7.** Transesophageal echocardiography in the mid-upper esophagus with 135° angle demonstrates the pacemaker wire (arrows) crossing the aortic valve, entering the left ventricle. There was no aortic regurgitation. AO = proximal ascending aorta; LA = left atrium.

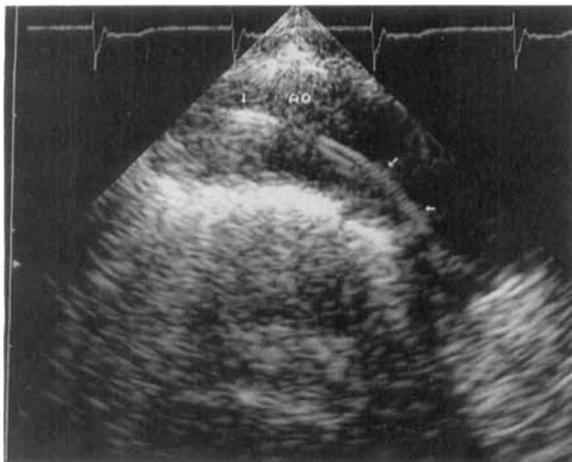
**Figure 6.** Transesophageal echocardiography from the upper esophagus of the thoracic aorta (AO). The pacemaker wire (arrows) courses retrograde.

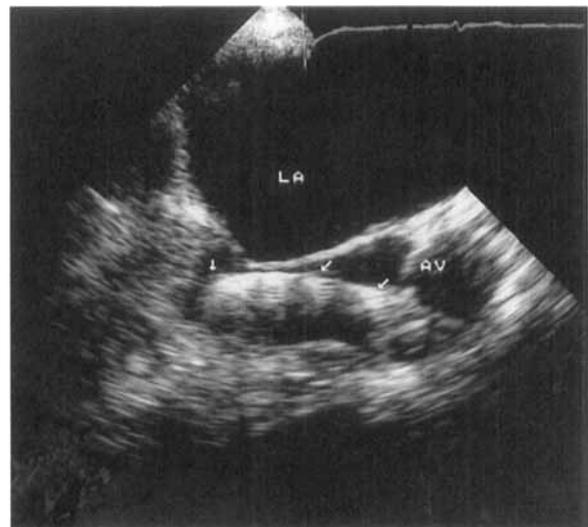
**Figure 8.** Transesophageal echocardiography in the mid-upper esophagus at 75° demonstrates pacemaker wire (arrows) within the left ventricular outflow tract. AV = aortic valve; LA = left atrium.

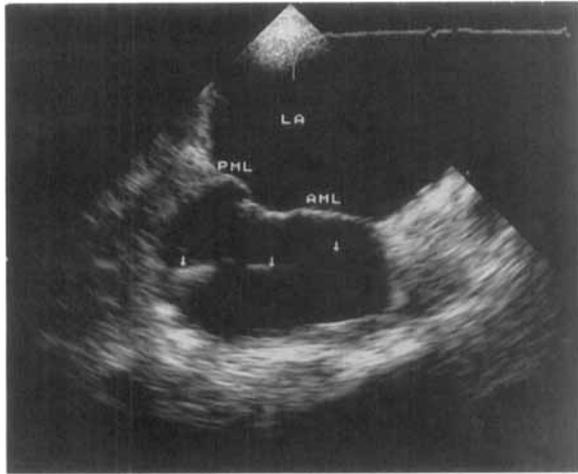
**Figure 9.** Transesophageal echocardiography in the mid-upper esophagus at 75° demonstrates the pacemaker wire (arrows) insertion site below the posterior mitral valve leaflet (PML) into the left ventricular wall. The papillary muscle was below the insertion site. A thrombus was noted by real-time imaging, attached to a papillary head. AML = anterior mitral valve leaflet; LA = left atrium.
